USE OF GNSS FOR THE REVIEW OF THE NATIONAL BOUNDARY BETWEEN SWEDEN AND NORWAY

Dan Norin¹, Martin Lidberg¹, Michael Munter¹, Anders Østeraas², Tor Erik Bakke²

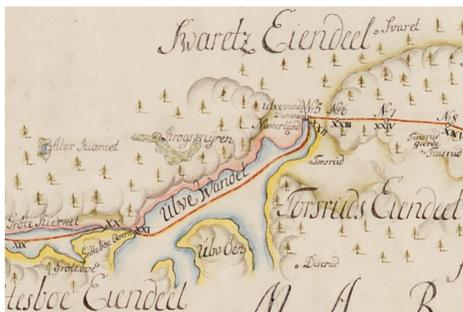
Figure 1: The main part of the boundary between Norway and Sweden (including Finland) was agreed through the Treaty of Strömstad in 1751. 349 national boundary markers (stone cairns) were built 1752–1766. Markers Rr 5–Rr 8 are located close to Lake Stora Ulvattnet.

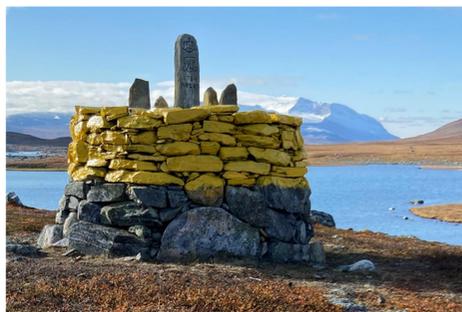
Figure 2: The stone cairns are large monuments up to two metres high. They have an up-standing central stone with inscriptions, where the original stone cairns from the 18th century bare the royal monogram's of the Swedish king Adolf Fredrik and the Danish king Fredrik V. Picture: Malcolm Skalin.

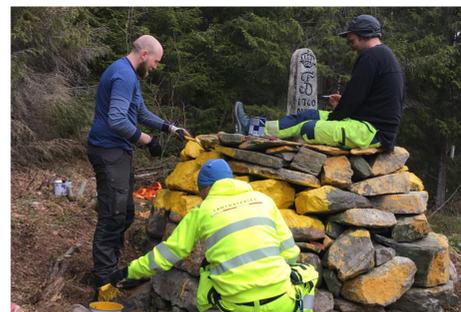
Figure 3: During the ongoing review of the national boundary 2020–2024, all boundary markers are restored, painted yellow and measured. The inscriptions on the central stone are filled in with black paint. Picture: Dan Norin.

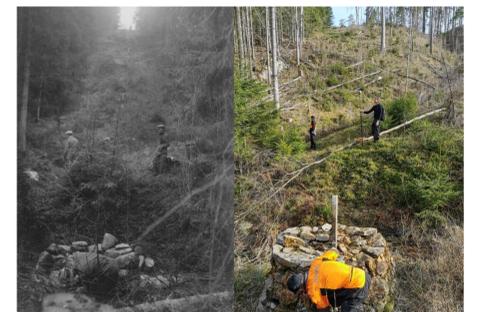
Figure 4: The fieldwork during the review of the national boundary 1929–1930 was done in a similar way as during the ongoing review. Rr A close to Idefjorden in the south is however nowadays positioned with more modern surveying technique. Picture: Lars Pettersson.

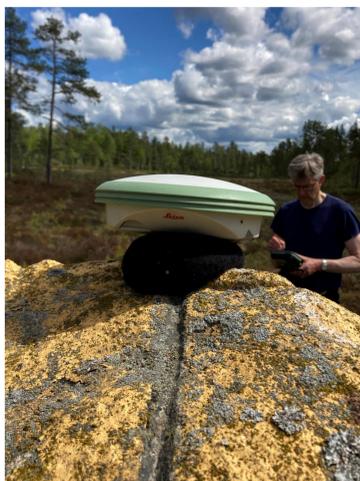
Figure 5: Norwegian Boundary Commissioner Anders Østeraas is surveying Rr 52B with a network RTK service (SWEPOS or CPOS). Rr 52B consists of a large natural stone. Picture: Dan Norin.

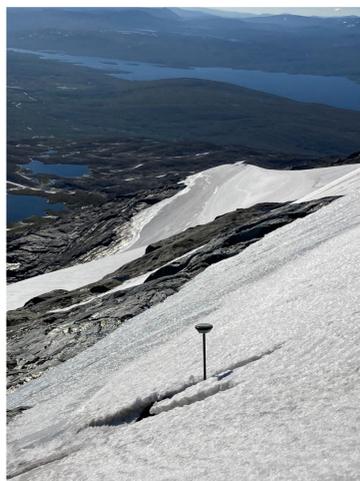
Figure 6: The highest point on the boundary between Sweden and Norway is located on the mountain Nuortta Sávlo (1752 metres above MSL). The boundary marker on the mountain (Rr 236Aa) was however difficult to find, since it nowadays is situated under a glacier. Picture: Dan Norin.

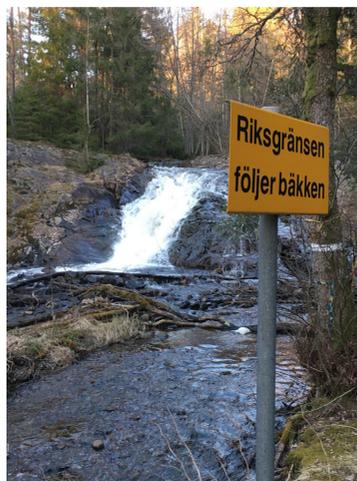
Figure 7: The boundary is along some stretches in the south part drawn in lakes and following rivers and creeks, which are indicated by signs. Some misspelled signs are replaced during the ongoing review. Picture: Dan Norin.

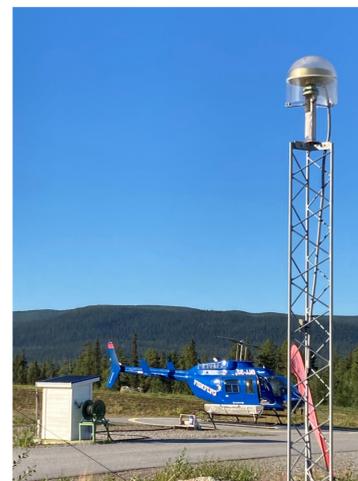
Figure 8: Helicopter transportation is essential to be able to carry out the ongoing review in remote locations. One helicopter base is located in Kvikkjokk, where a permanent reference station for GNSS in the SWEPOS network is also located. Picture: Dan Norin.

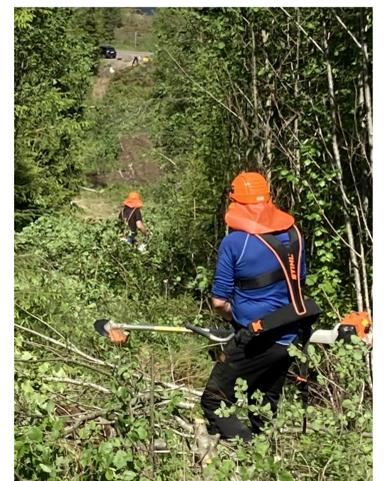
Figure 9: The five-metre-wide clearing along the boundary line is (below the tree line) made free of trees and shrubs. Picture: Dan Norin.

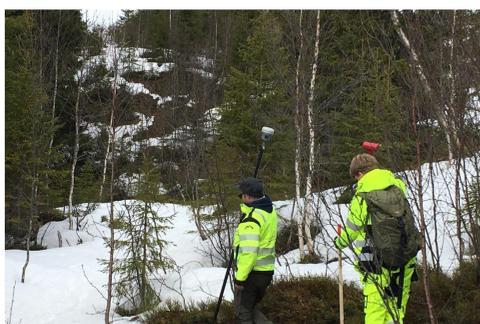
Figure 10: To be able to get a straight five-metre-wide clearing between the boundary markers, the boundary line is set out with network RTK and marked with wooden sticks. Picture: Dan Norin.

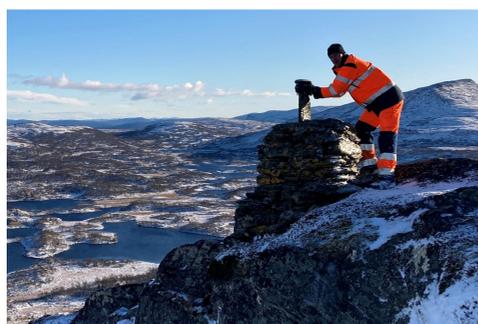
Figure 11: “Utliggare” are smaller stone cairns which only show the boundary line, not defining it. These are also measured with GNSS. Picture: Karl Tirén.

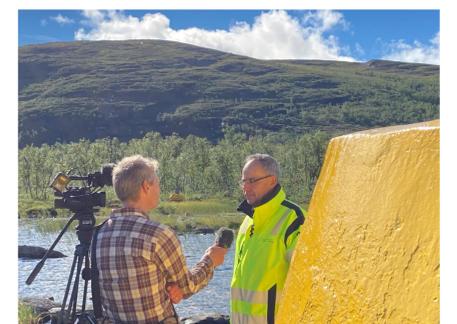
Figure 13: Swedish Boundary Commissioner Martin Lidberg explained in Swedish national TV that the restoration of Treiksröset was successful. During the repair of the lower part of the cairn, affected by the fact that it is situated in a lake, 260 kilograms of mortar was used. Picture: Dan Norin.
