# 2020–2024 REVIEW OF THE NATIONAL BOUNDARY BETWEEN SWEDEN AND NORWAY

Dan Norin<sup>1</sup>, Anders Østeraas<sup>2</sup>, Martin Lidberg<sup>1</sup>, Tor Erik Bakke<sup>2</sup>, Per Sörbom<sup>1</sup>

During 2020–2024, a review of the boundary has been carried out. The Swedish and Norwegian governments appointed boundary commissions at Lantmäteriet and Kartverket respectively to carry out the review together. Practically, Sweden was responsible for the work on the northern part of the boundary and Norway on the southern part. All kind of boundary markers have been restored, painted and measured with GNSS (mainly network RTK). A five-metre-wide clearing has been secured (below the tree line) and made free of trees and shrubs. The documentation of the review, still in process to be confirmed, consists of 1447 pages including

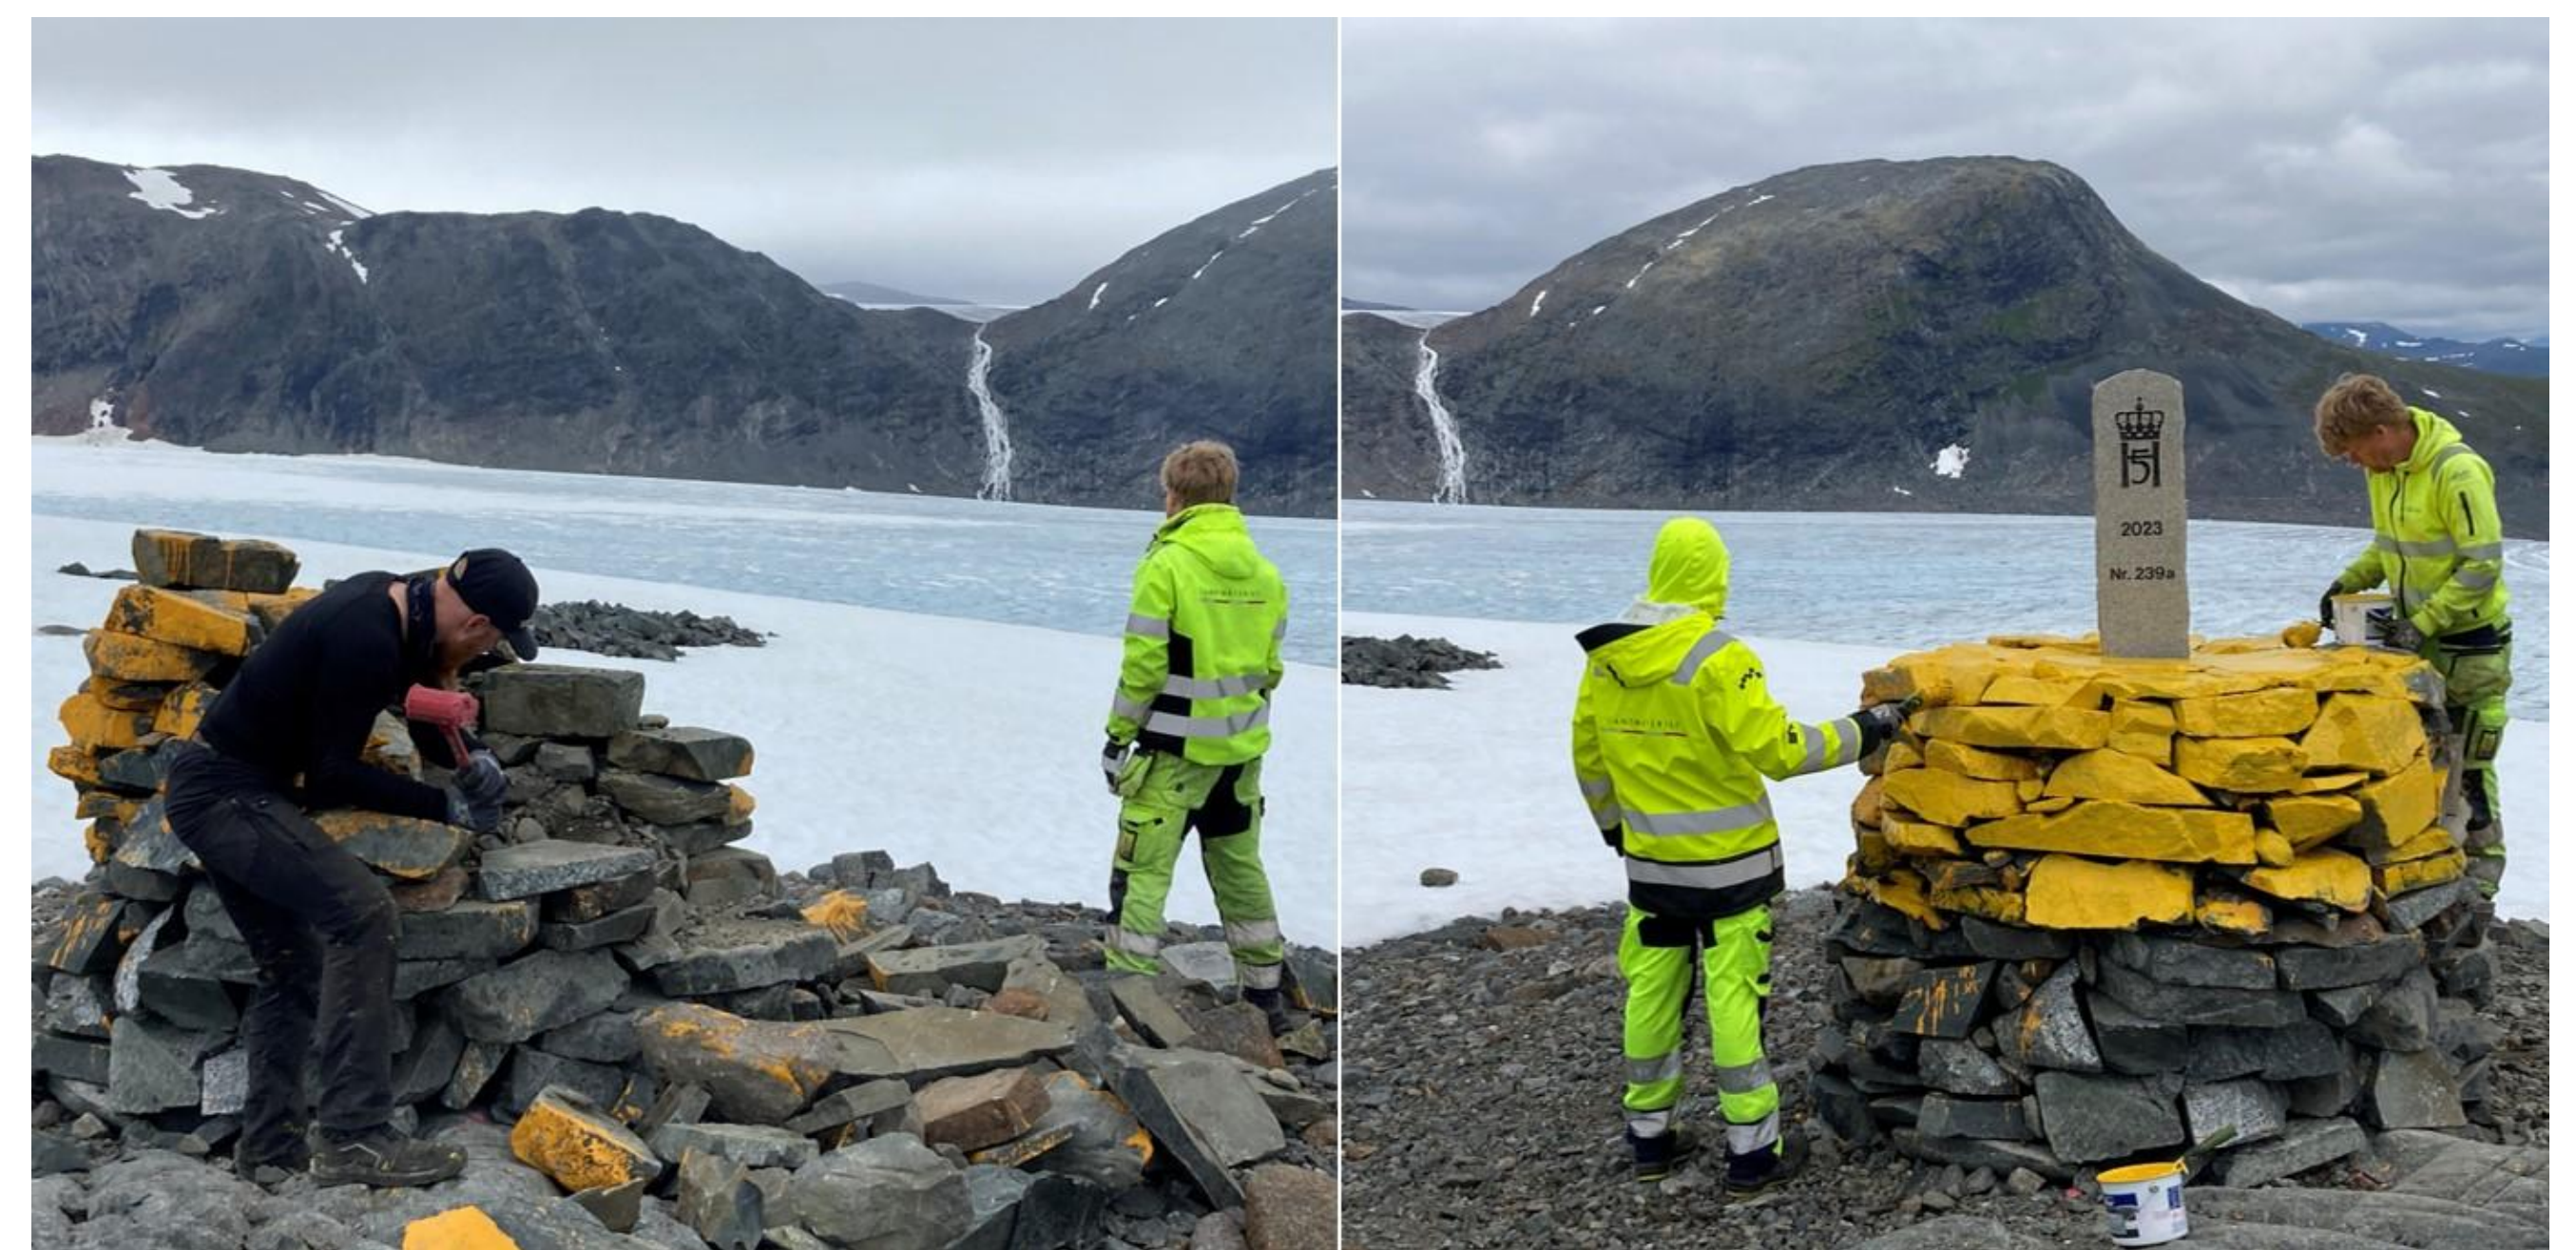
**Figure 3:** All boundary markers have been thoroughly restored and it have in some places been necessary to replace the central stone with a new one.

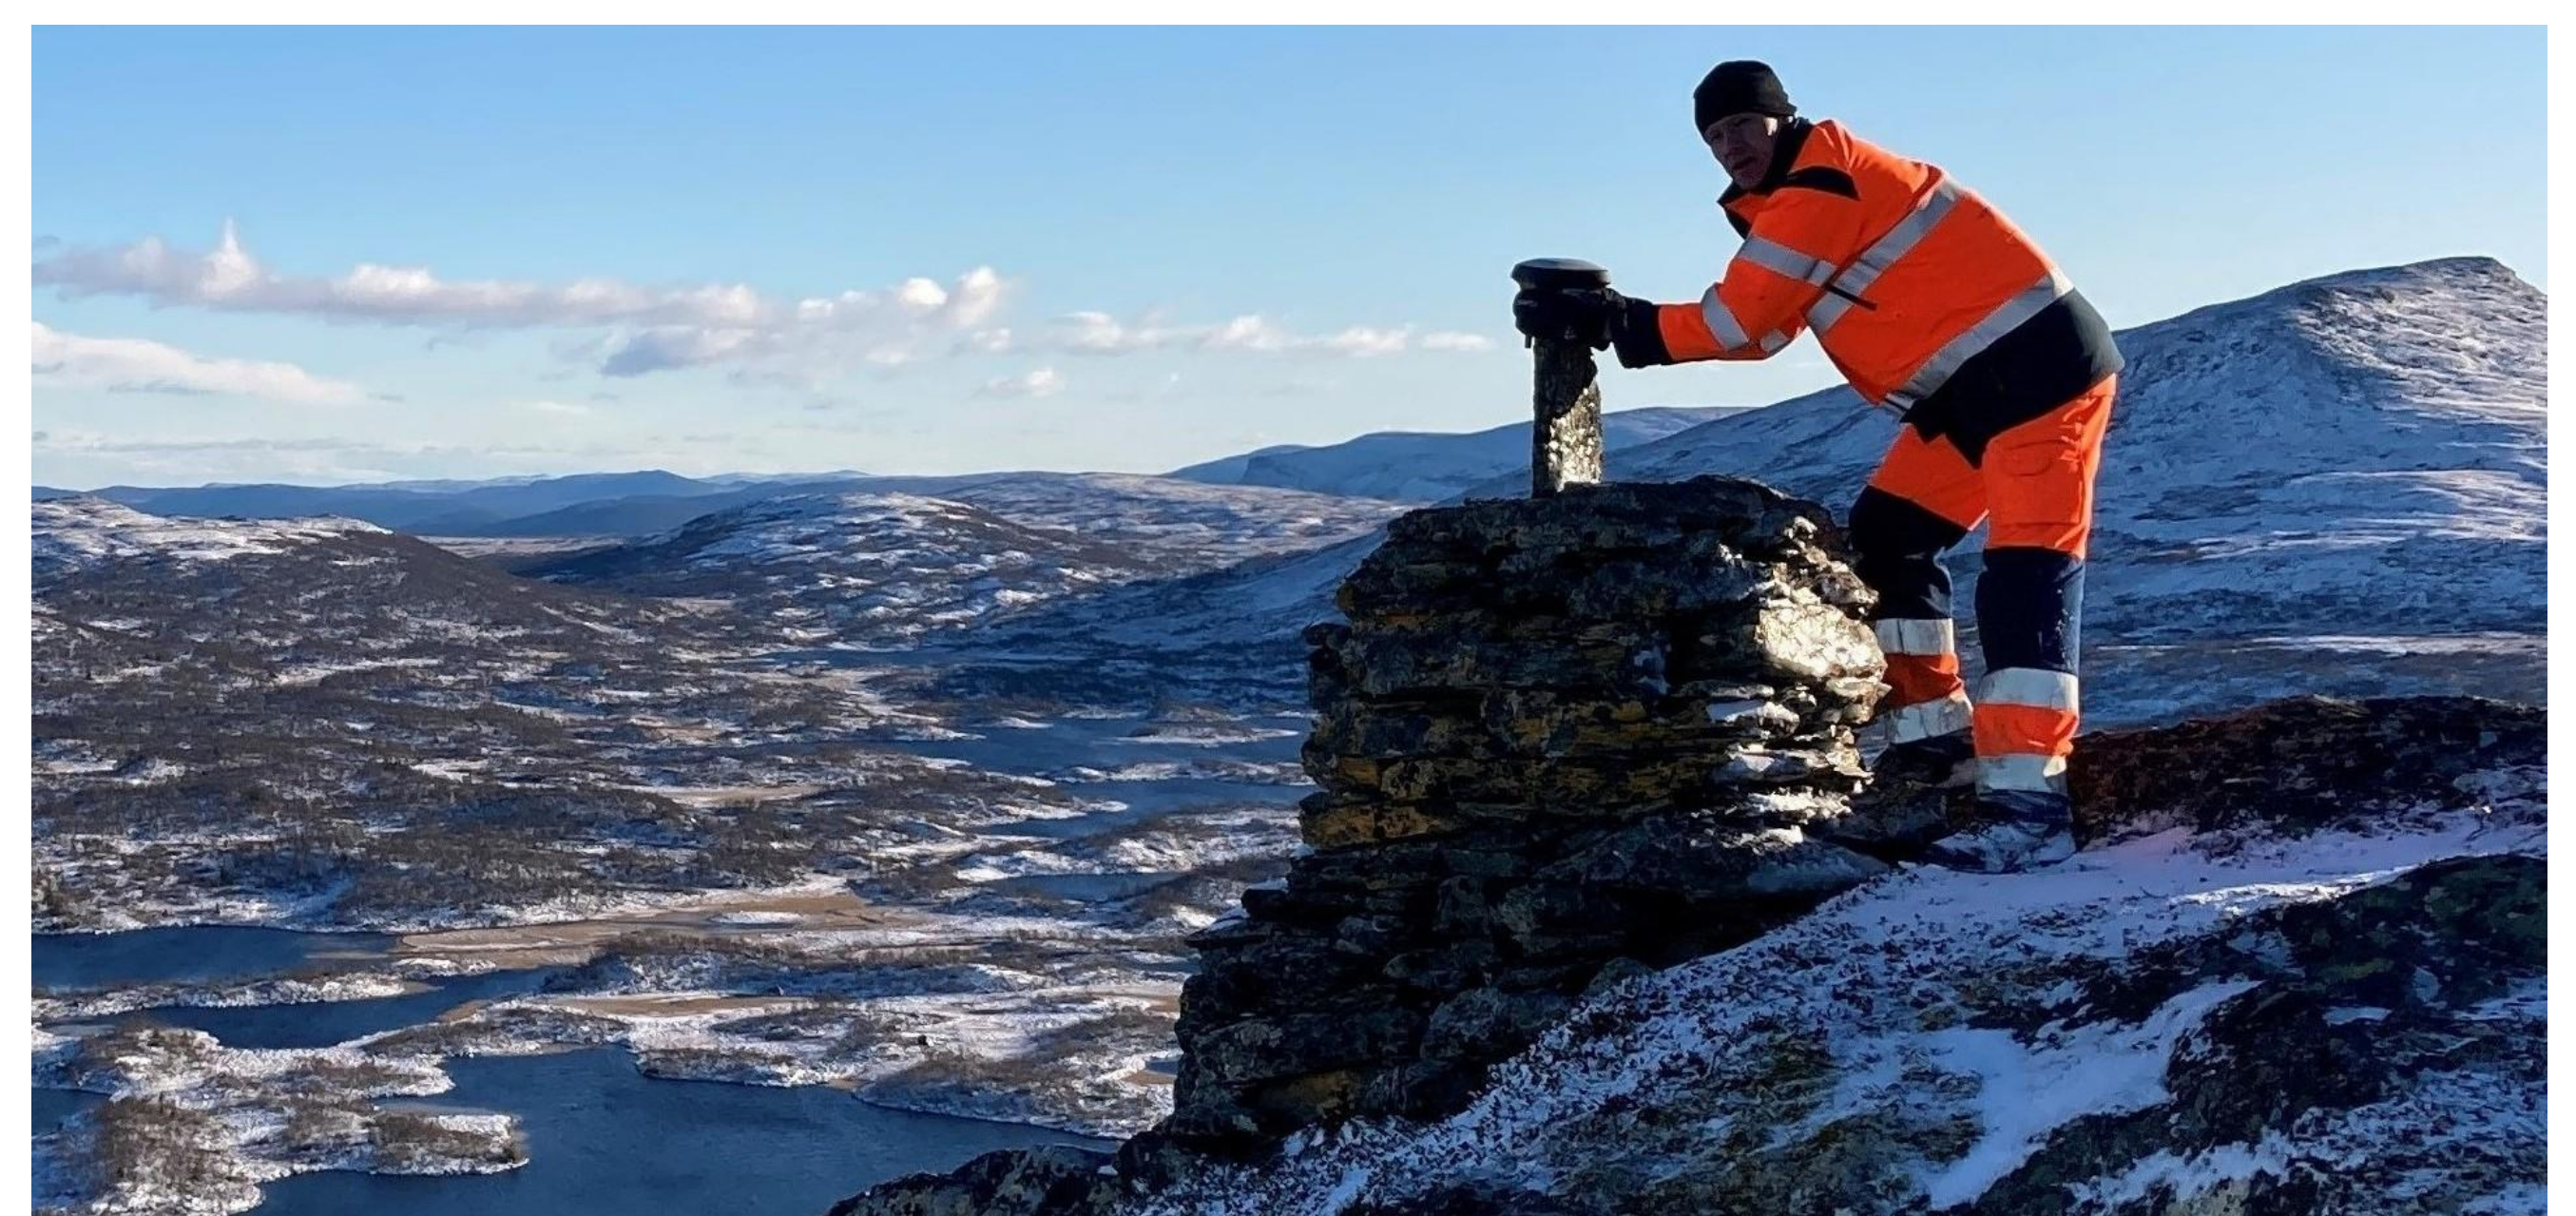
**Figure 4:** All boundary markers were surveyed with GNSS (mainly network RTK through SWEPOS or CPOS services). This boundary marker is a so-called utliggare.

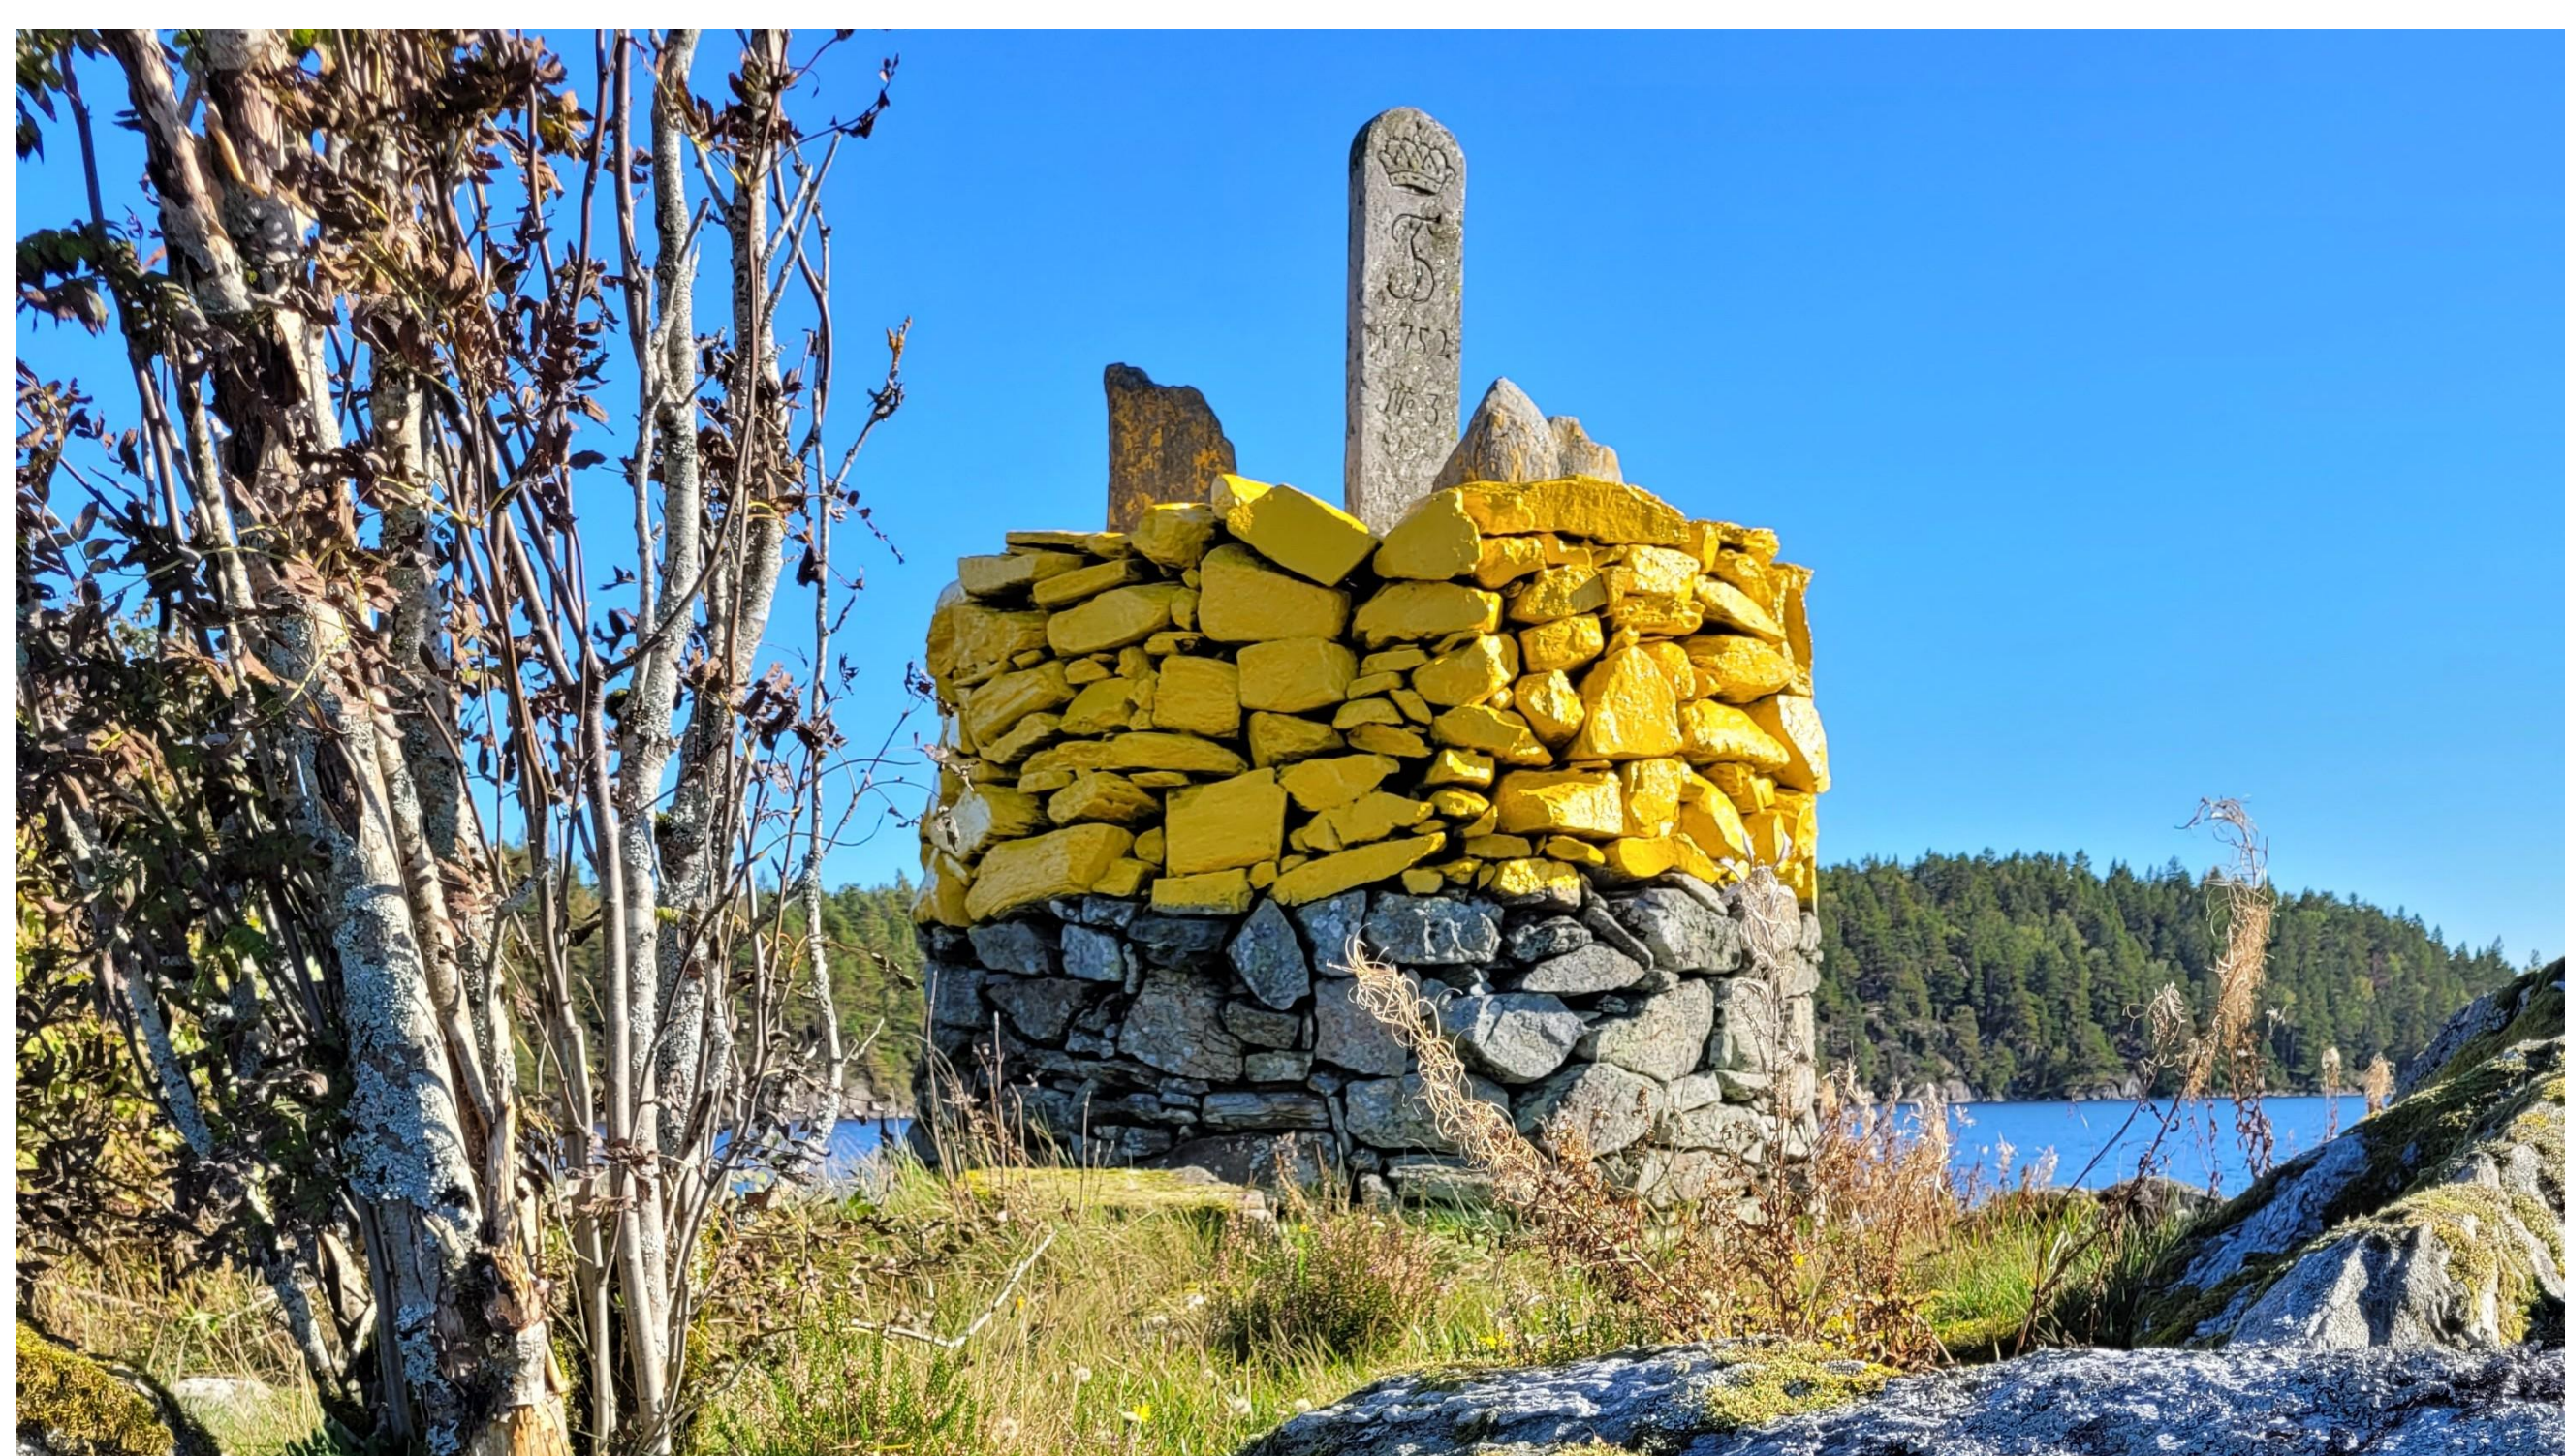
**Figure 1:** Boundary marker no 3 is an original stone cairn from 1752.

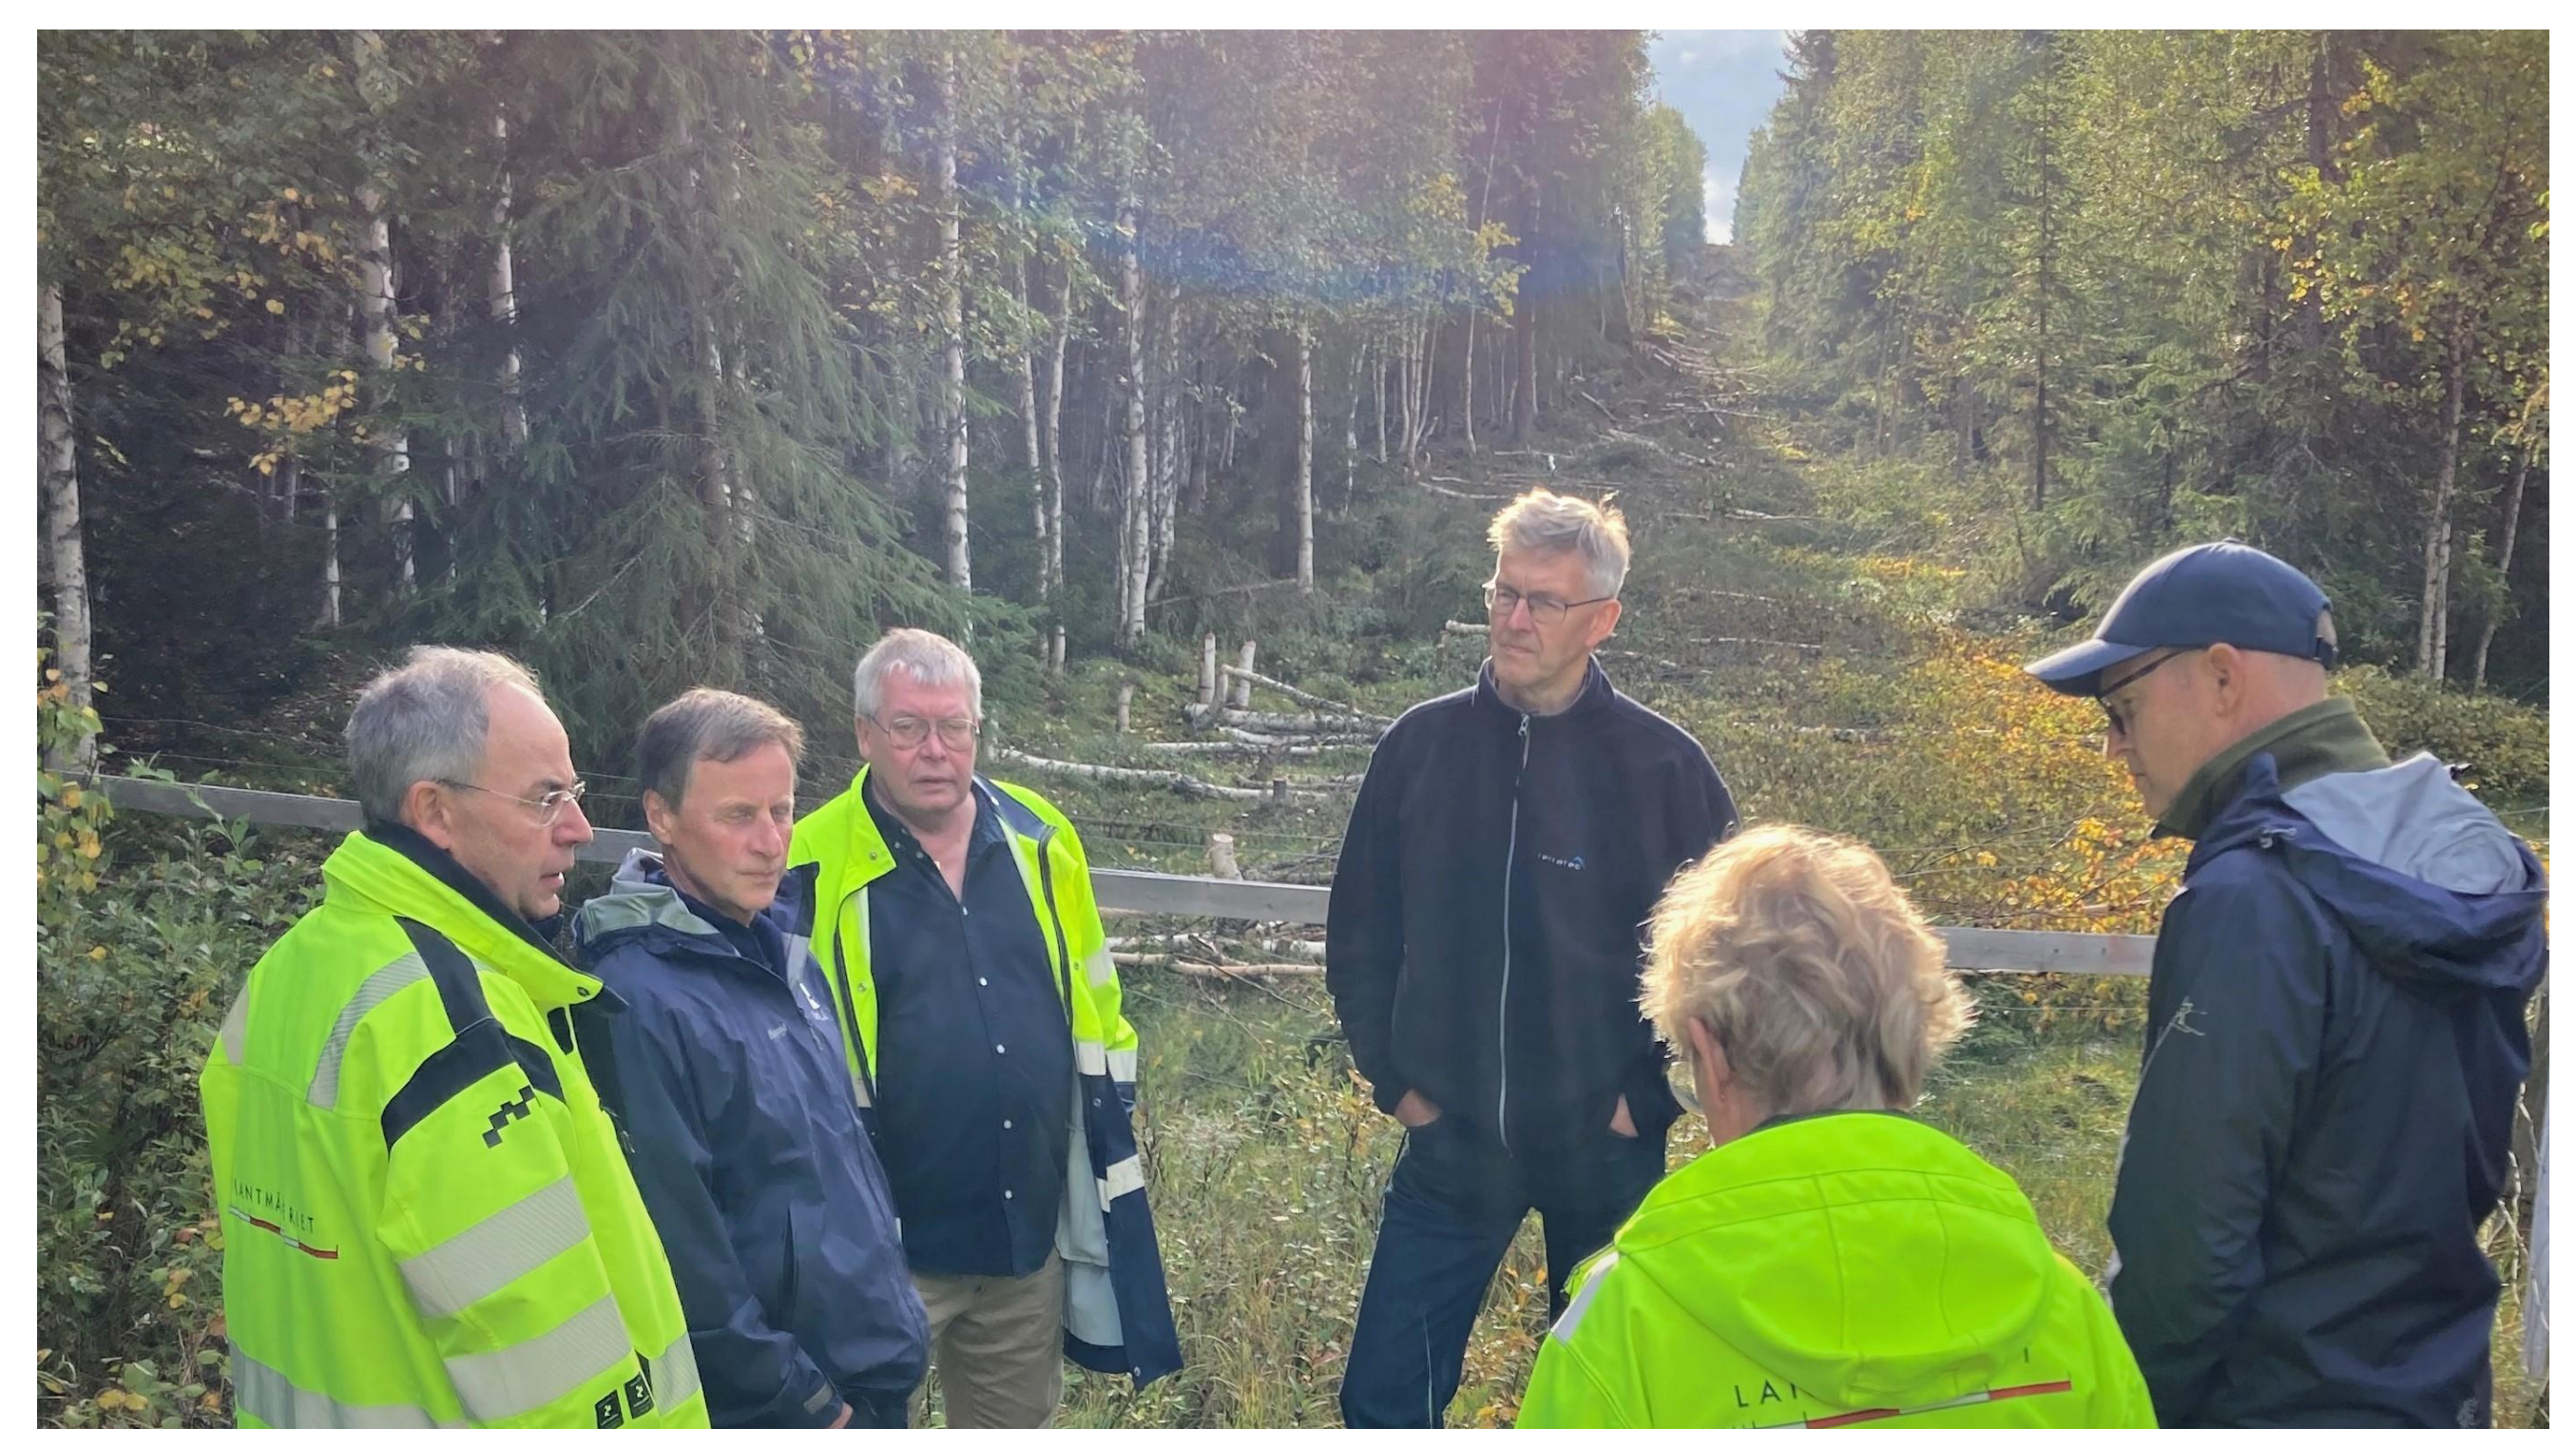
**Figure 5:** Inspection of the five-metre-wide clearing by the boundary commissions.

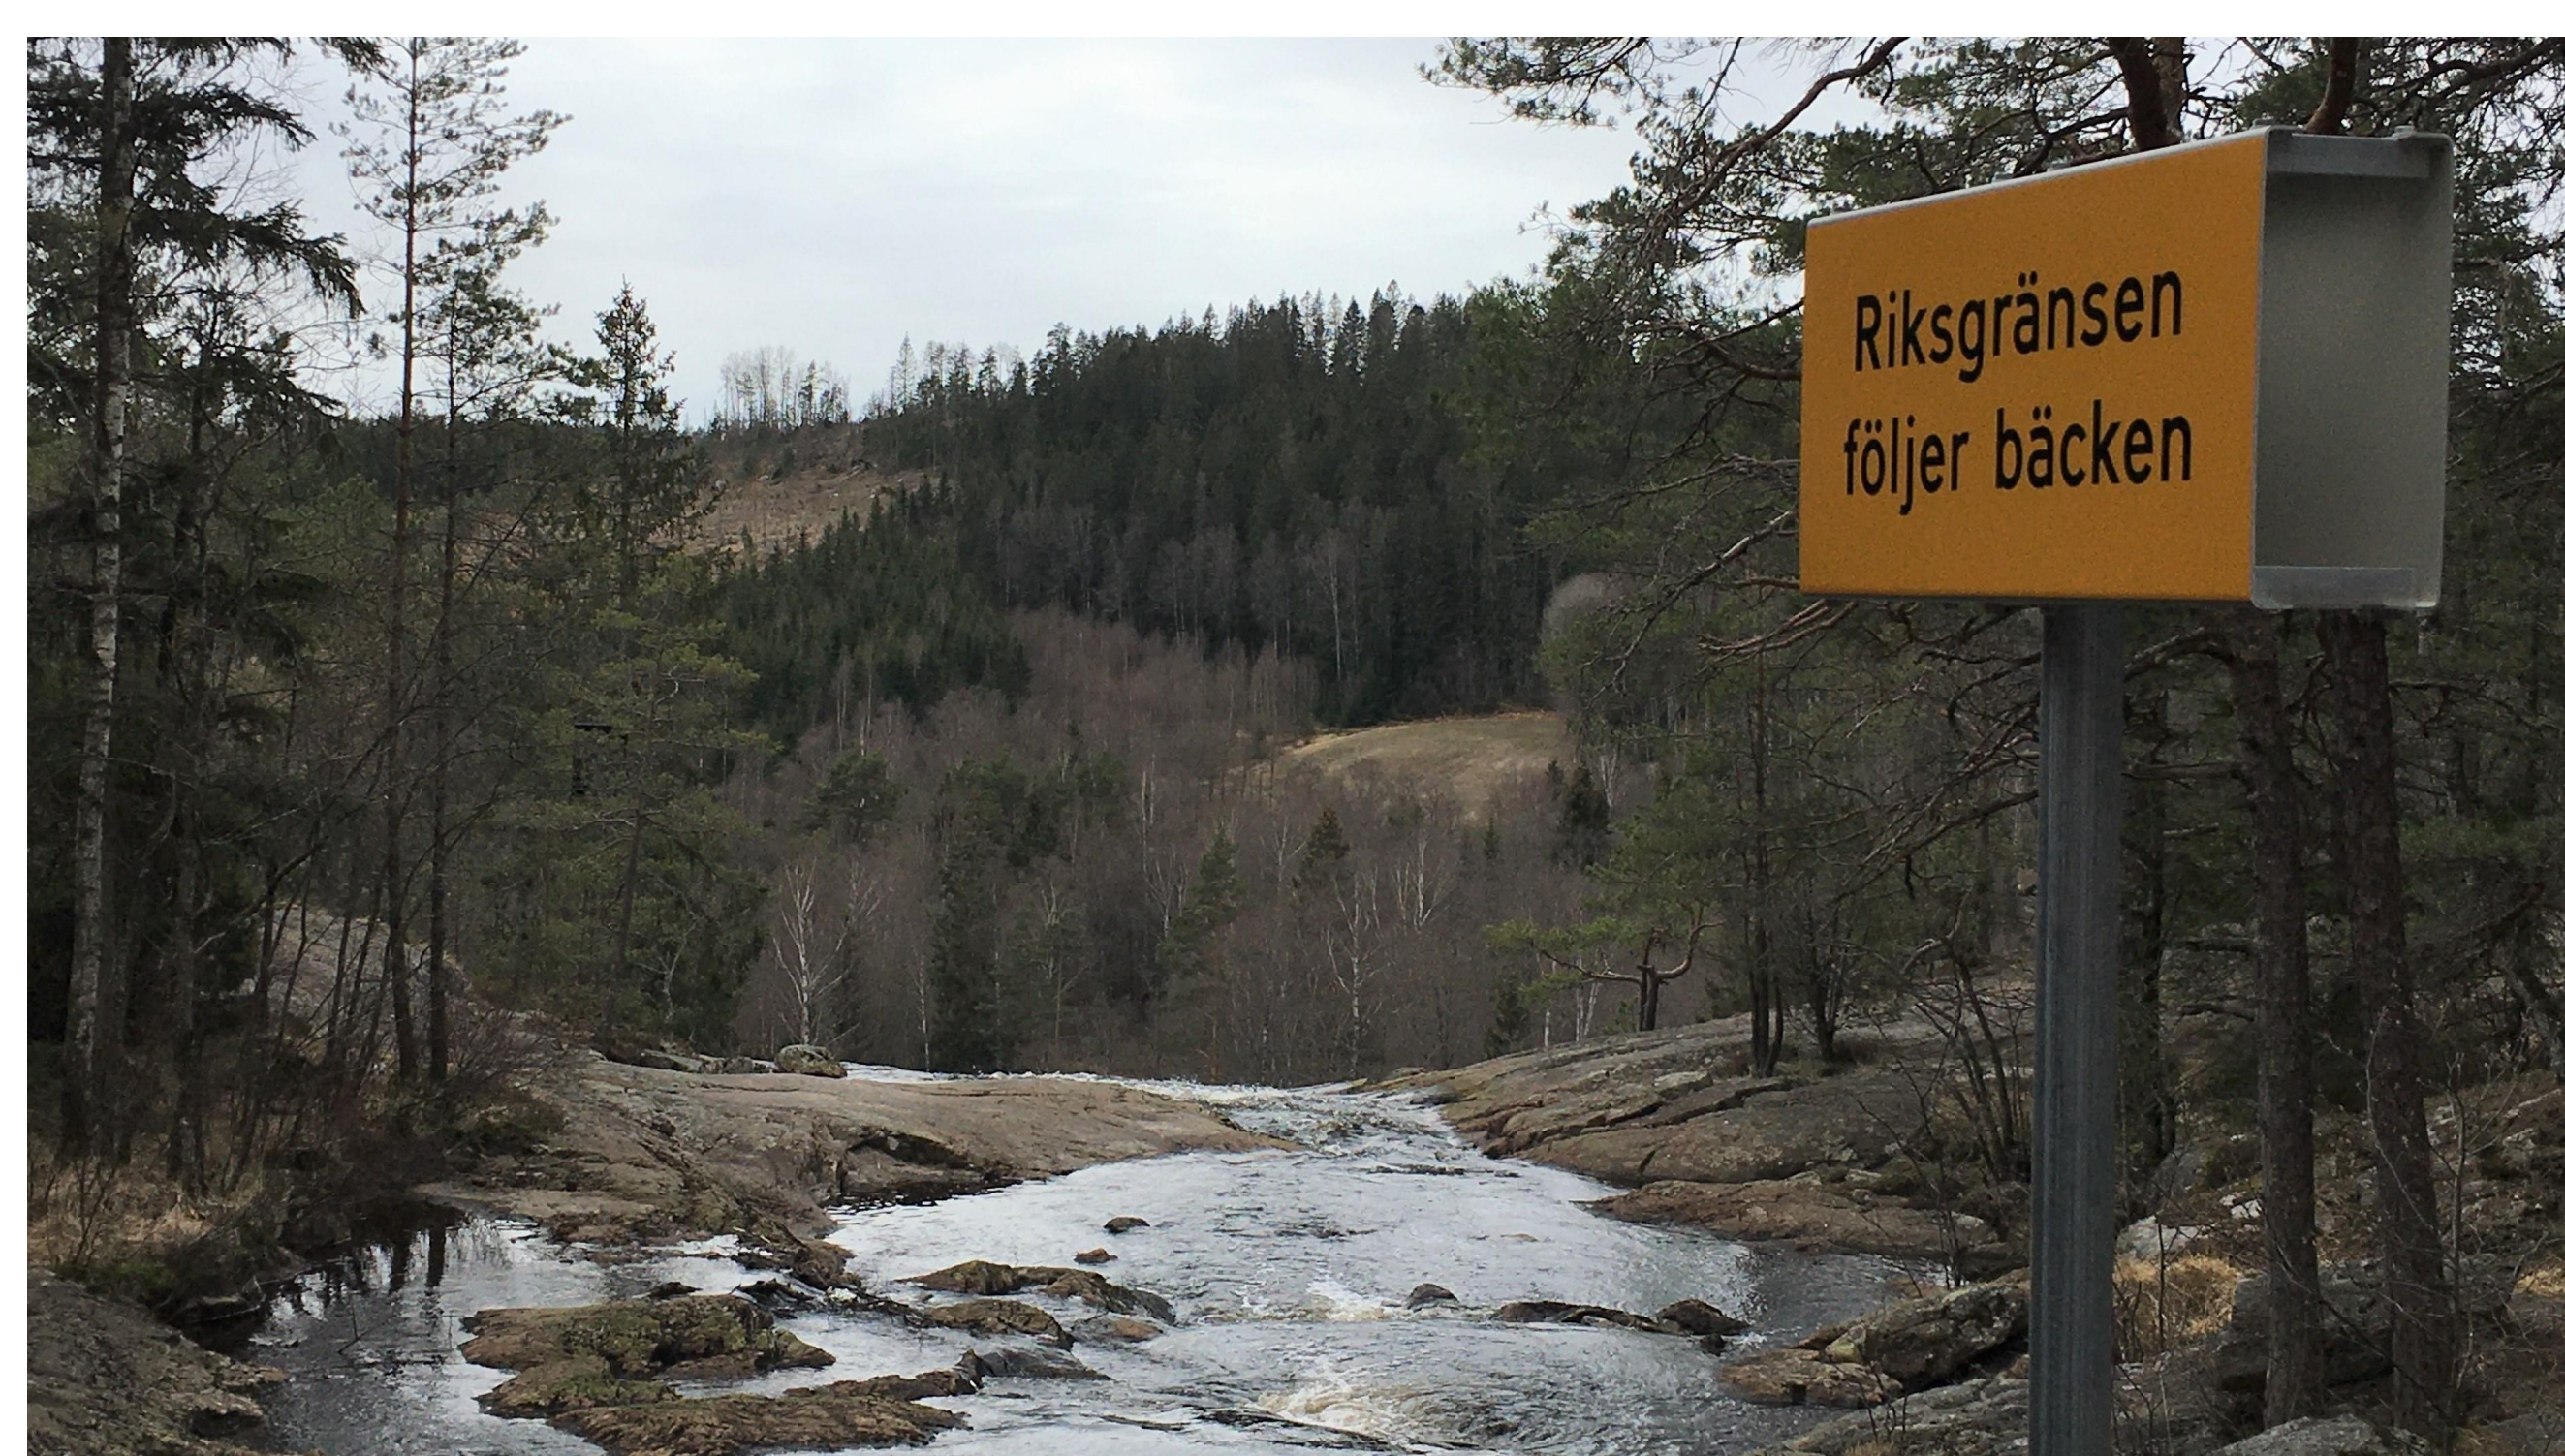
**Figure 2:** The boundary is along some stretches in the south part drawn in lakes and following rivers and creeks, which is indicated by signs.
